Corrosion Report

Equipment Location ID 0955-003-001
Equip. Location Descrip. C-1100 OVHD

**CHEVRON
RICHMOND FACILITY
AUT REPORT
CRUDE OVERHEAD
LINE
APRIL 2011**

Crude unit overhead line inspection 5/11/2011

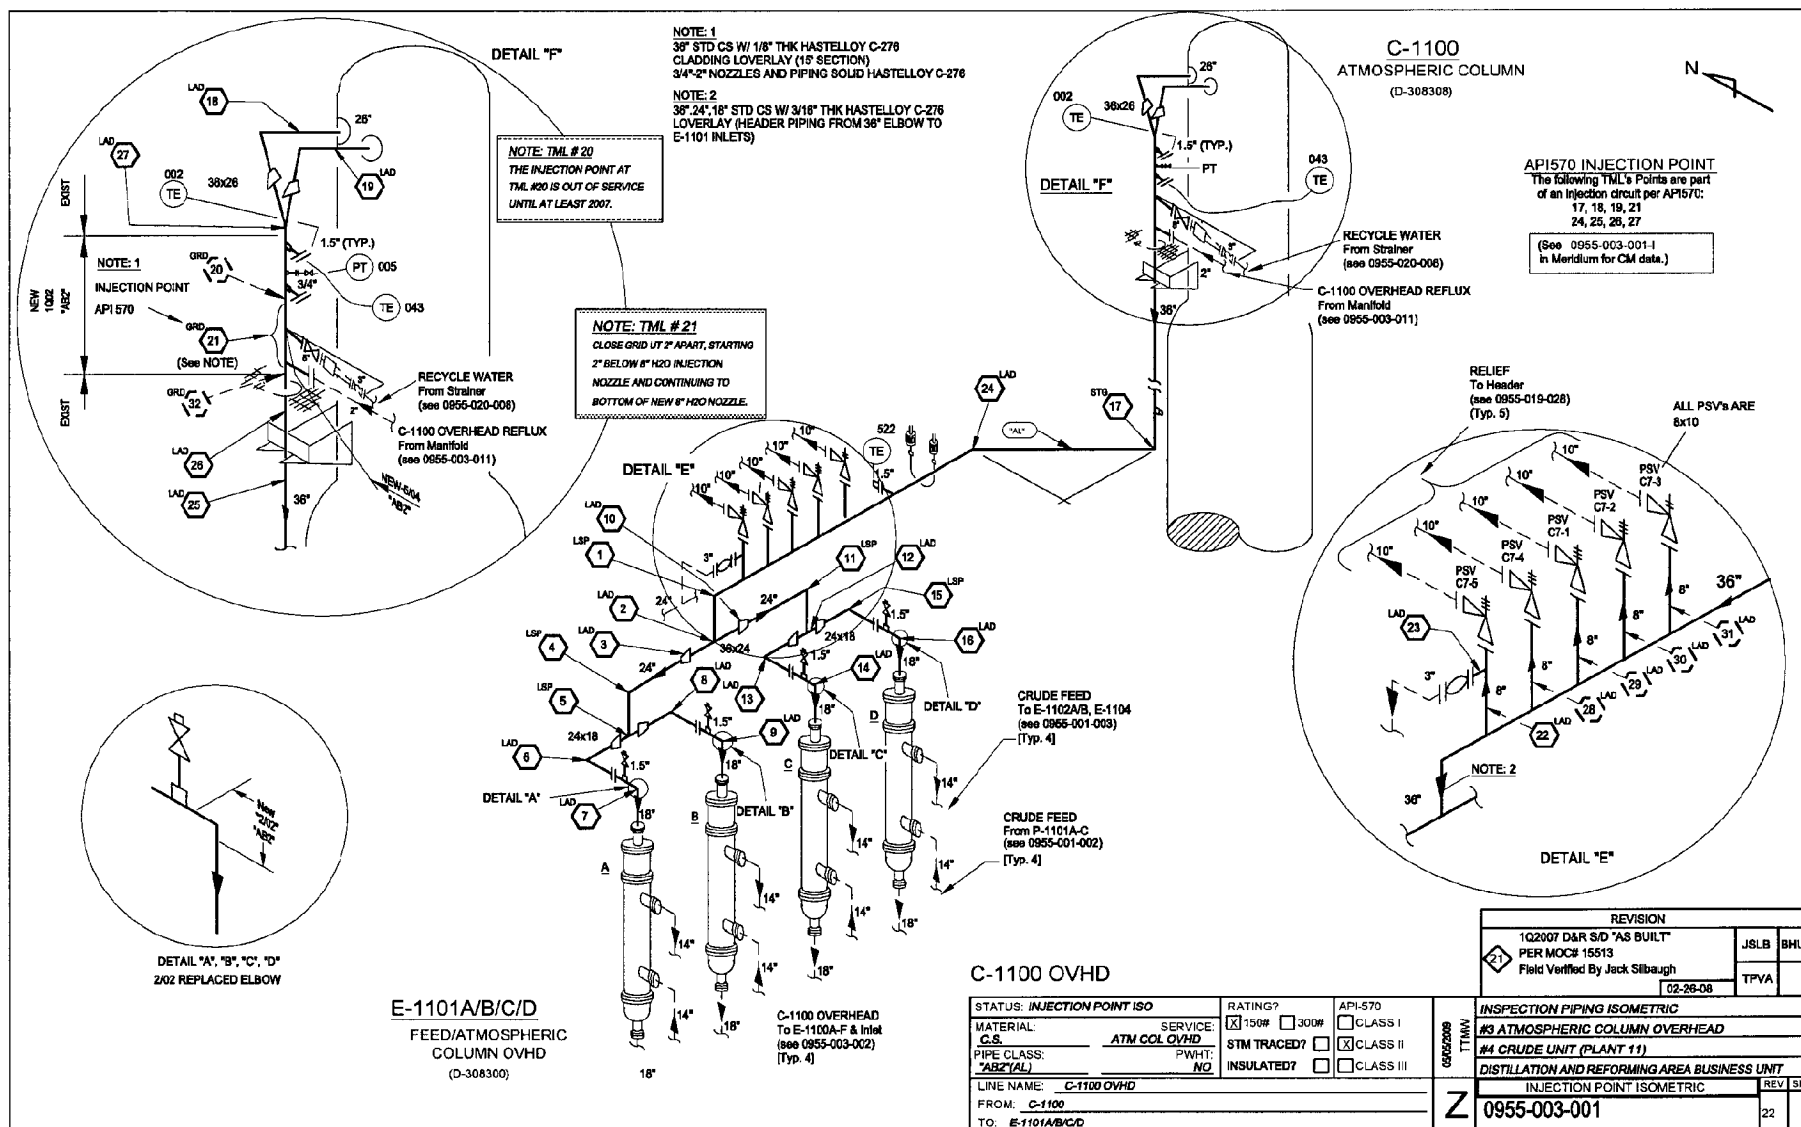
TML 27

LOOKING EAST.

Hand UT Scan was performed on the elbows due to geometry and inability of using the AUT machine. CML 27 at the Y connection near the top of C-1100 above the hastelloy overlay has an area that is corroding at 0.007" per year short term and a remaining life of 17 years. We re-inspect this area every 3 years because it is an injection point and we will monitor as needed. There is no recommendation for the Oct. 2011 event at this time.

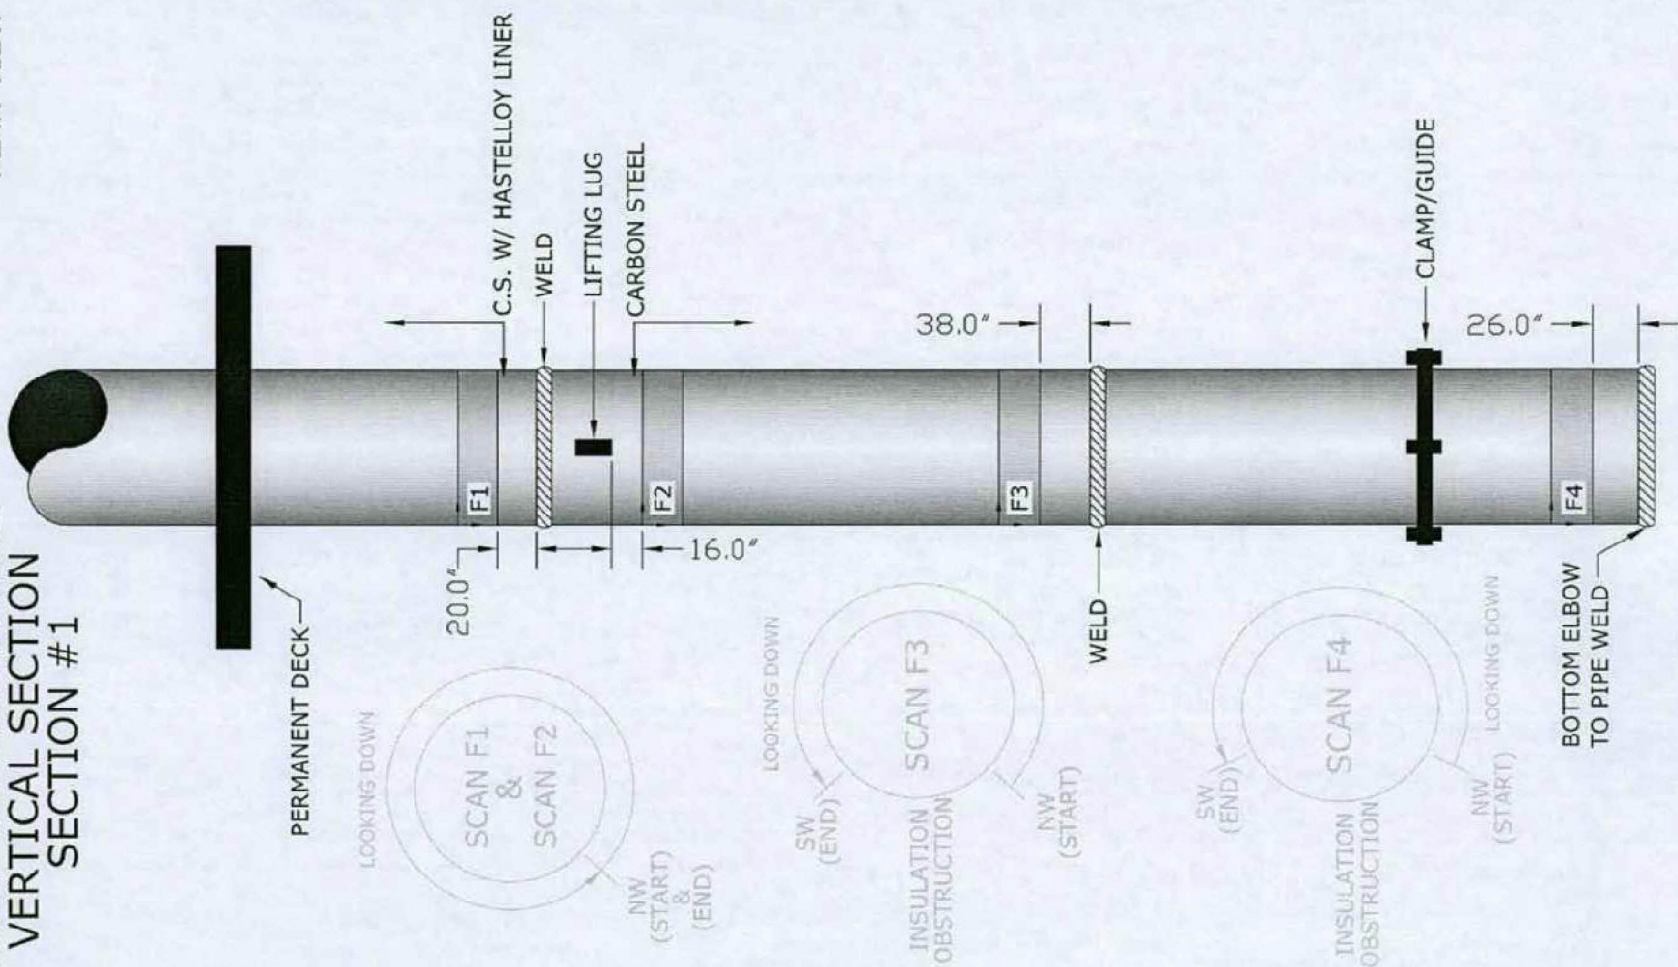
CRUDE OVERHEAD LINE VERTICAL SECTION SECTION #1

The Crude Overhead line has two sections that were replaced during the 2007 S/D due to internal corrosion at the inlet elbow to E-1101D. There are two areas protected with a corrosion resistant hastelloy weld overlay as noted on the drawing. These areas appear to be nominal thickness with no detectable active corrosion. The inspection was concentrated on the unprotected Carbon steel areas of the vertical and horizontal run of the overhead line. These areas are actively corroding please see corrosion rate and remaining life calculations below. Current Remaining Life using Refinery Replacement Thickness for the thinnest area is 78 years located on section 3. The elbows were inspected by hand using a 1" x 1' grid pattern. This is the first AUT scan of this area so we are using a long term corrosion rate. We will scan this area again prior to the 2016 S/D to determine the short term corrosion rate at a repeatable location.

.297" worst location found

.002" per year based on long term corrosion rate from 1/1976 – 5/2011.

A remaining life to 0.140" in thickness is calculated to be 78 years at the current corrosion rates.
